Thermal Trend

Infrared Thermographic Inspection  
Of  
Selected Electro-Mechanical Equipment

Provided For  
Acme Paper Mill  
3/9/2003

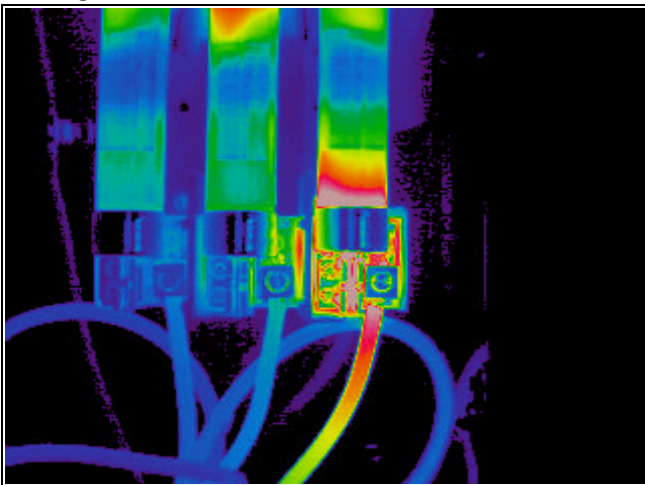
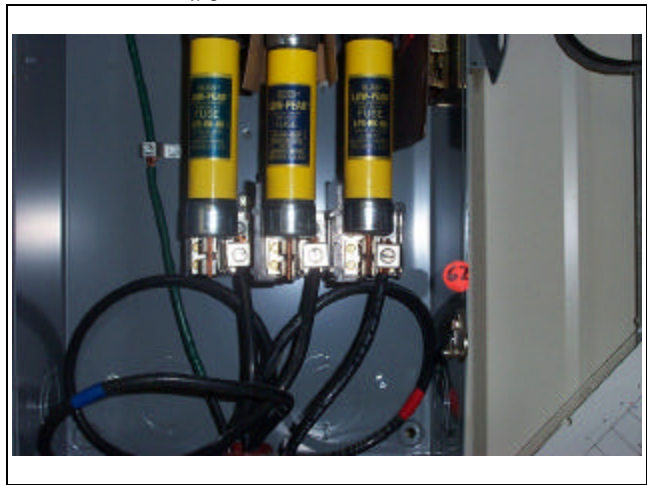
Inspection # 19	Problem # 62
Problem Date/Time 3/10/2003 2:18:17 PM	
Indirect Temp. Measureme No	
Component Temp 275 @ 72%	
Reference Temp 100 @ 72%	
Temp Rise 175 @ 72%

Component: C phase load side wire lug/fuse clip connection on fused disconnect switch.

Probable Cause Loose or corroded connection

Recommendation Clean inspected and retorqued wire lug and retension fuse clip

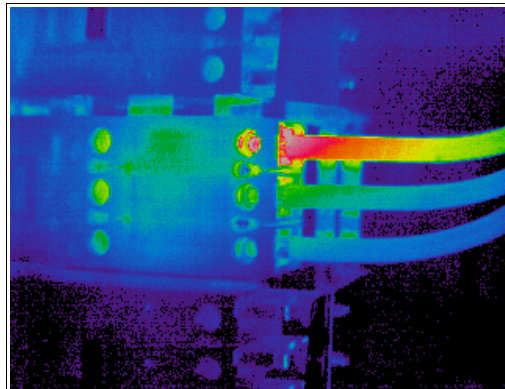
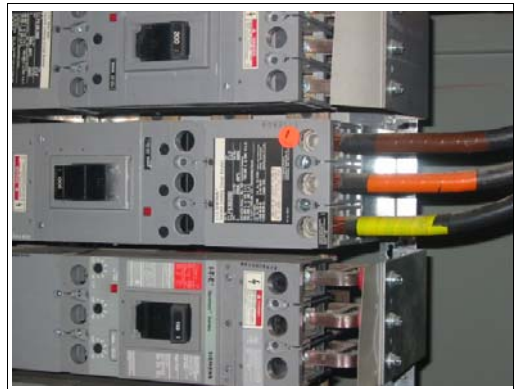
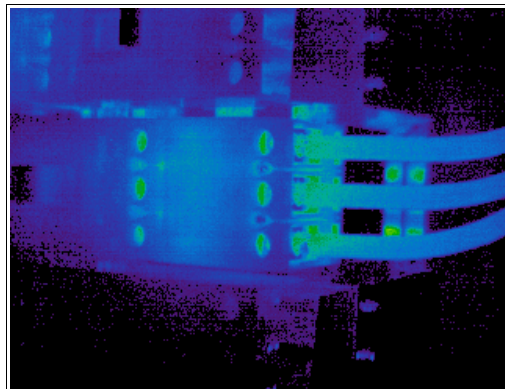
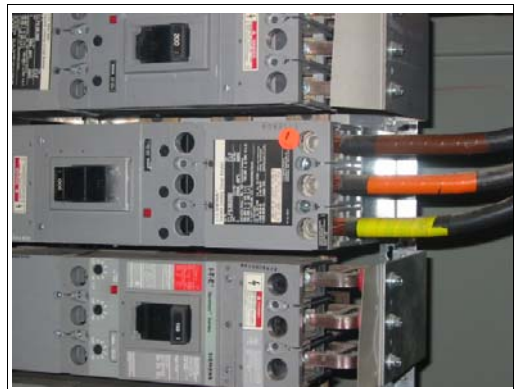
Component: A (top) phase load side wire lug connection on circuit breaker for PANEL PDP-1

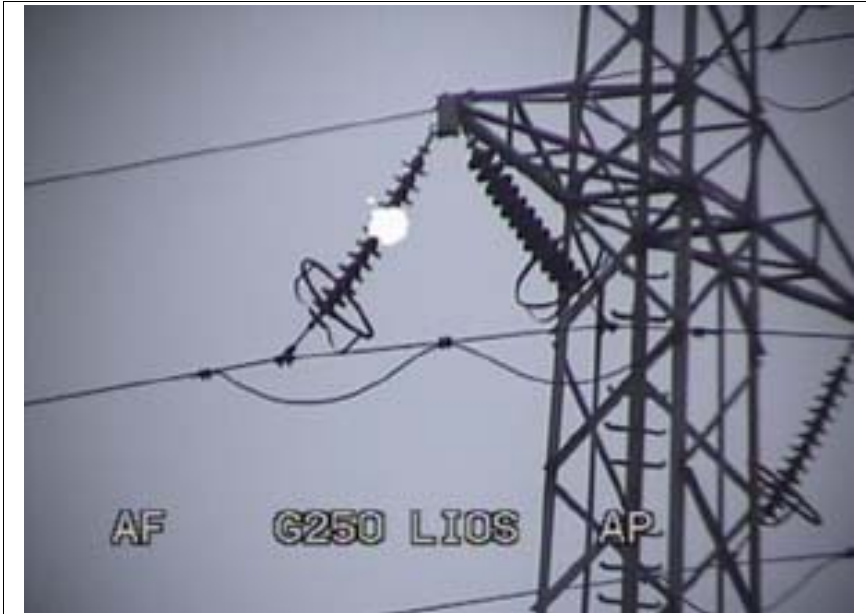
**Component:** Center phase west end of tower line insulator is showing corona in the center of the insulator.

**Probable Cause:** Cracked insulator bell

**Recommendation:** replace insulator

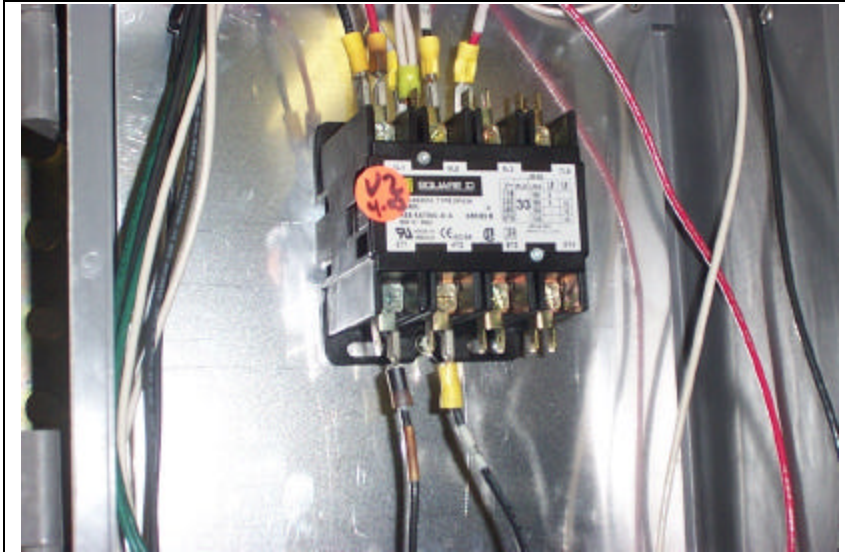
**Component** Left phase line & load side crimp connections are burnt & discolored (#36), not running at time of inspection.

**Probable Cause** Bad crimp connections

**Recommendation** Replace crimp connections.

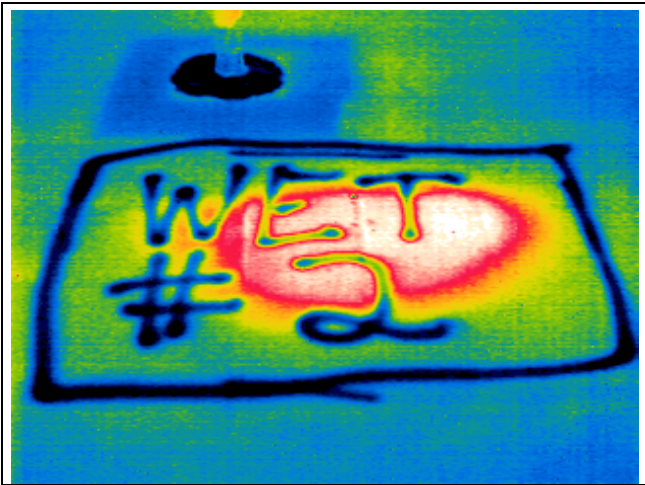
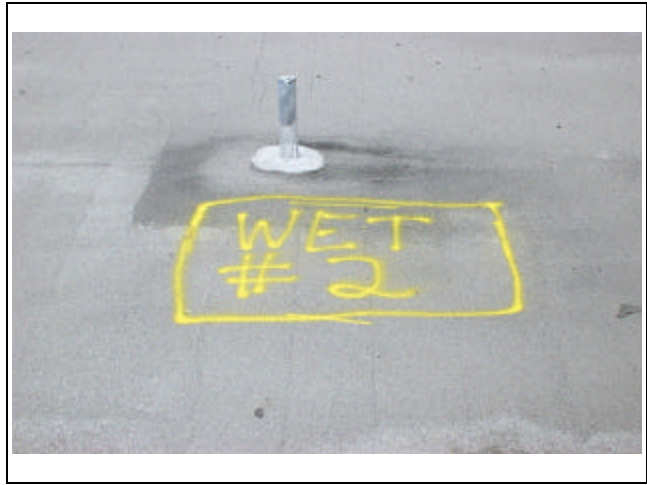
**Component** Northwest end of roof. IR taken at night, photo taken the next day.

**Note** Core cut taken Insulation is 1/2" fiberboard, 3" of fiberglass on wood decking.

**Probable Cause** Wet Insulation caused by moisture intrusion

**Recommendation** Remove wet insulation

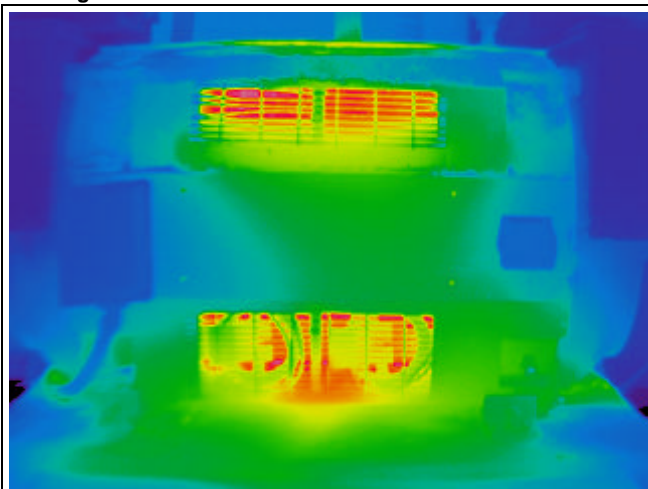
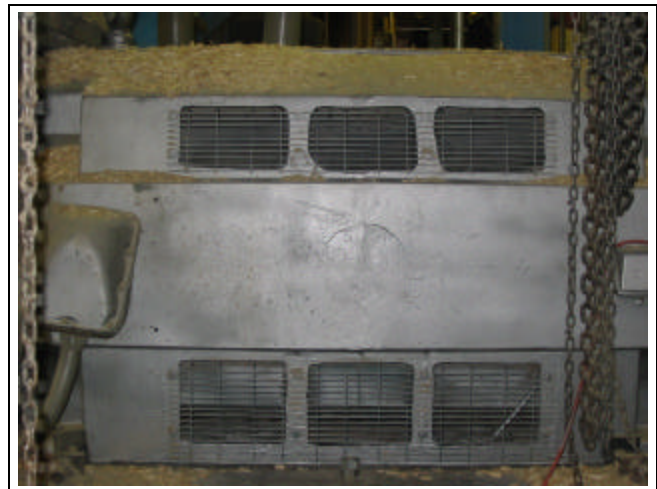
Inspection # 5	Item # 1
Problem DateTime: 10/9/2003 4:22:57 PM	
Indirect Temp. Measurement No	
Component Temp: 300 @ N/A	
Reference Temp: 175 @ N/A	
<b>Temp Rise 125 @ N/A</b>

Component MOTOR BASELINE TAKEN FROM EAST SIDE
